Sony APR-5000 Reel Motor Drive Board

RMD BOARD
 BOARD NO. 1-619-160-11 & HIGHER
 APR-5002/5003

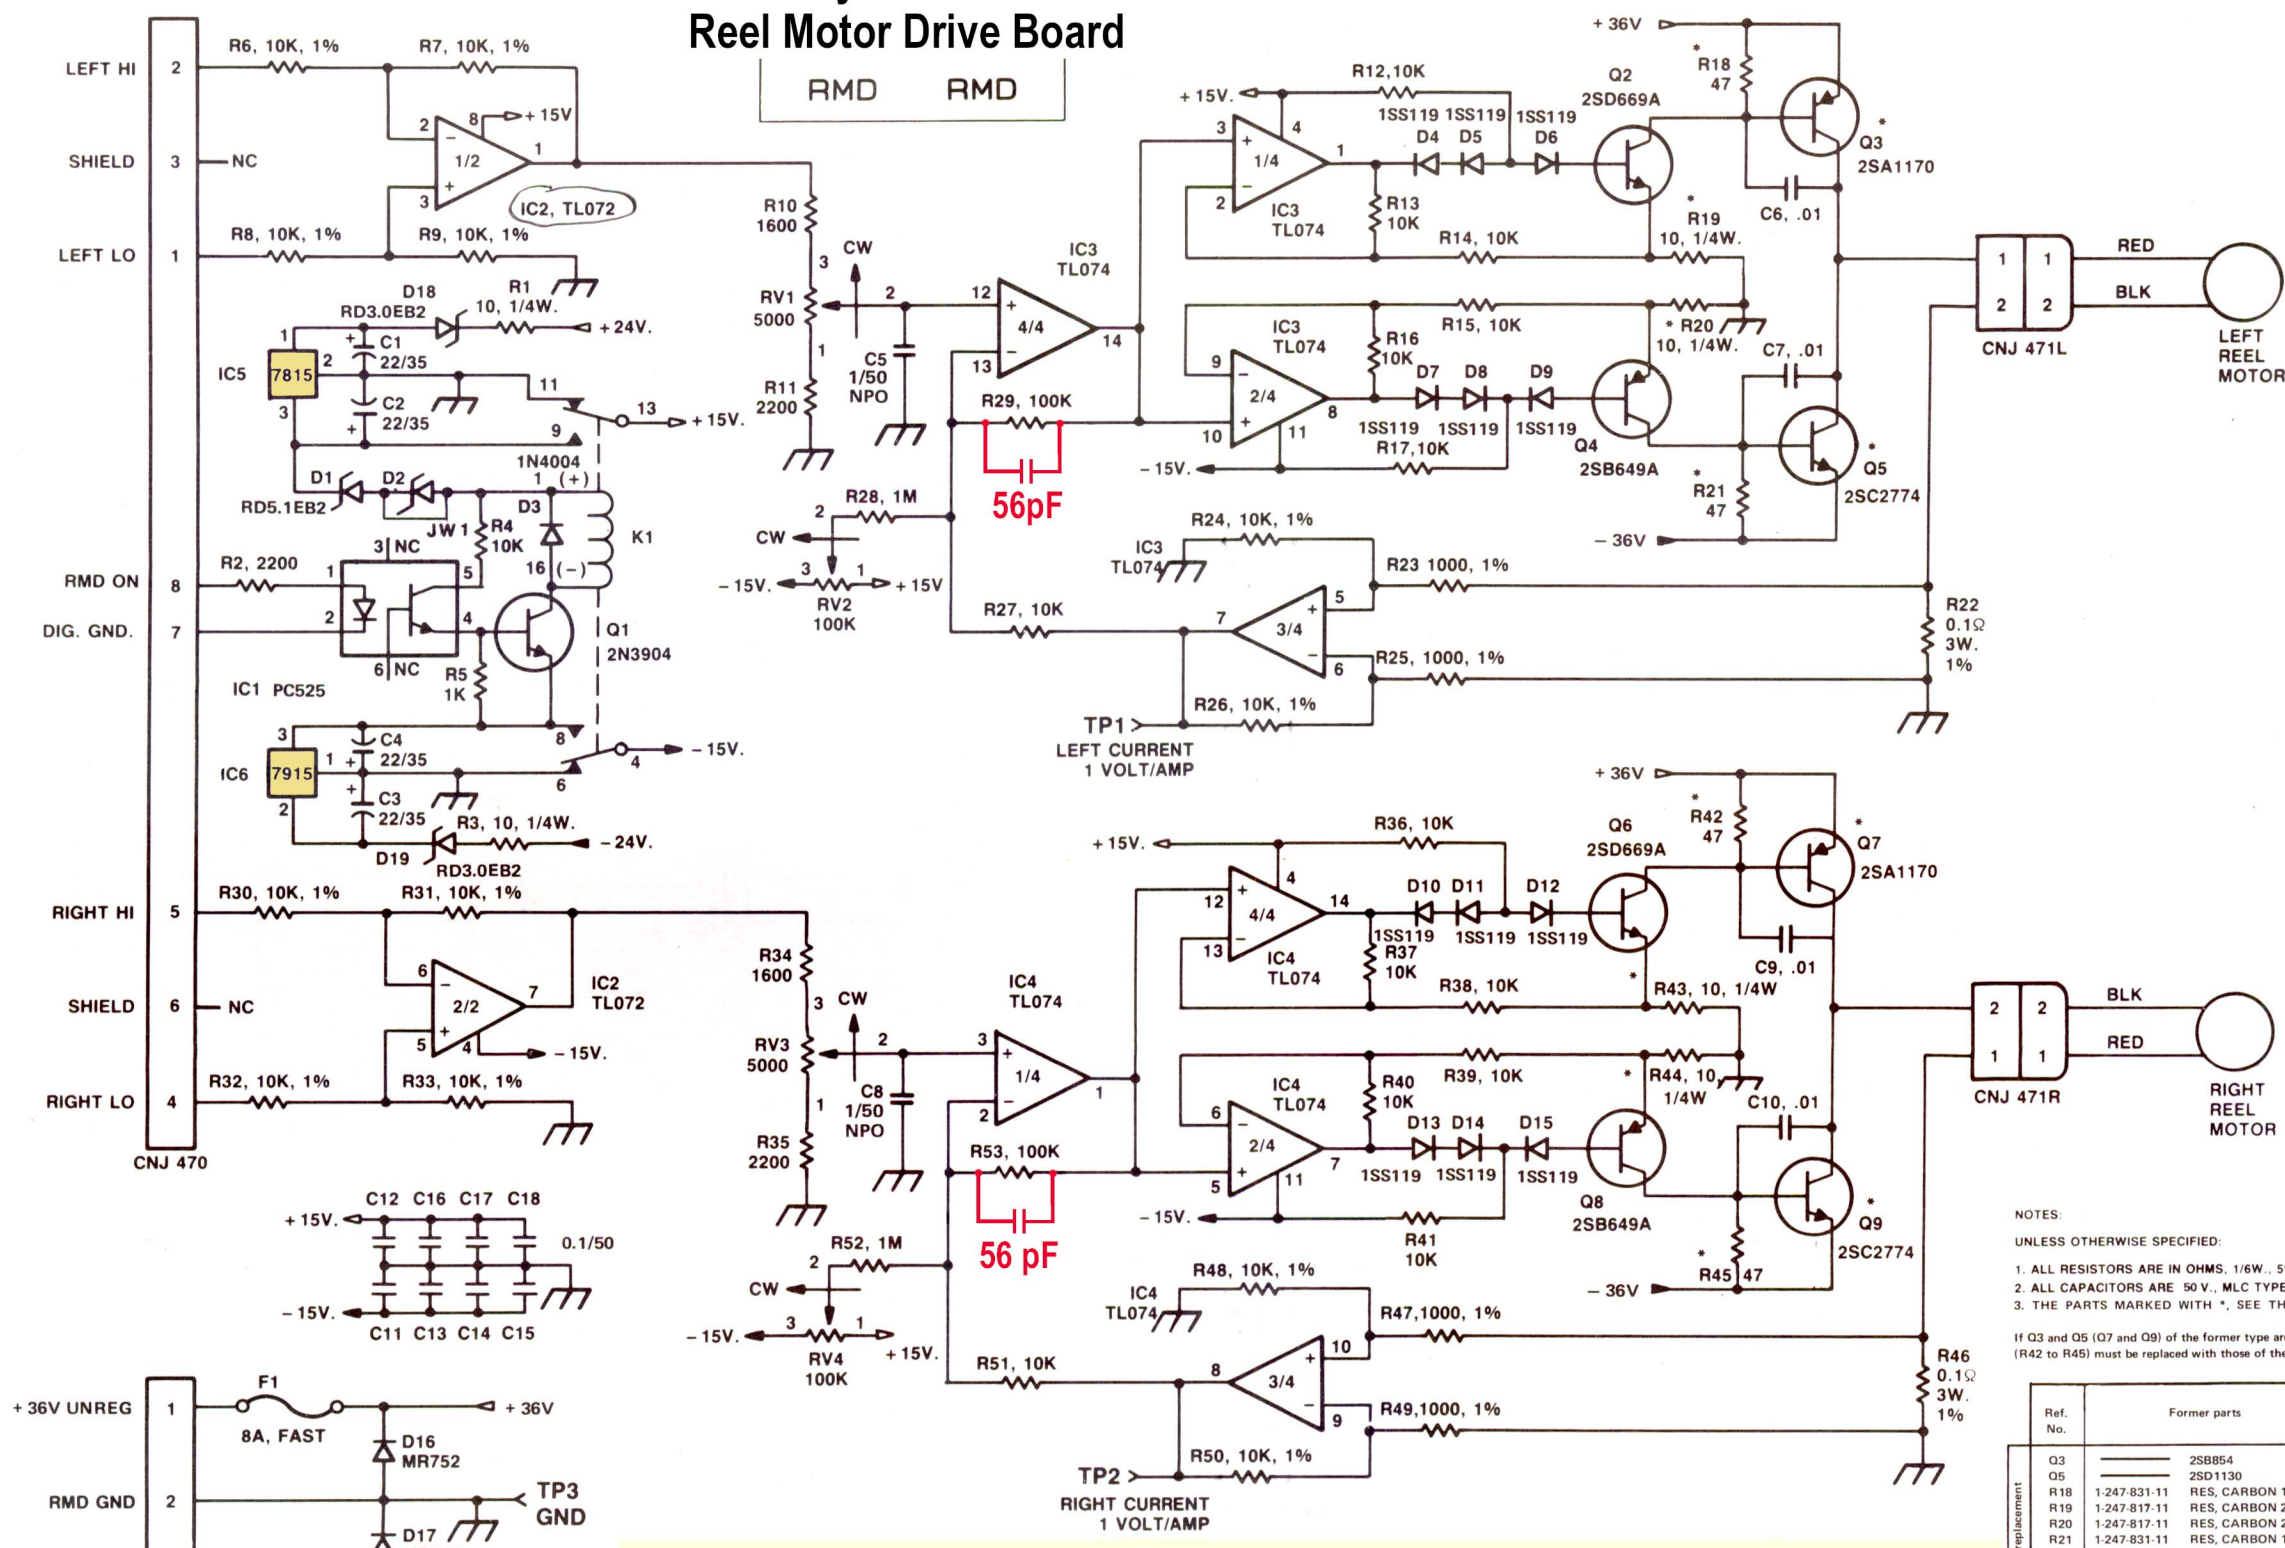
NOTES:
 UNLESS OTHERWISE SPECIFIED:
 1. ALL RESISTORS ARE IN OHMS, 1/6W., 5%.
 2. ALL CAPACITORS ARE 50 V., MLC TYPE.
 3. THE PARTS MARKED WITH *, SEE THE FOLLOWING TABLE.
 If Q3 and Q5 (Q7 and Q9) of the former type are replaced with those of the new type, R18 to R21 (R42 to R45) must be replaced with those of the new type at the same time.

If card is oscillating...

Ref. No.	Former parts	New parts
Q3	2SB854	8-729-300-24 2SA1170
Q5	2SD1130	8-729-300-18 2SC2774
R18	1-247-831-11 RES, CARBON 1K	1-249-401-11 RES, CARBON 47
R19	1-247-817-11 RES, CARBON 270	1-247-688-11 RES, CARBON 10
R20	1-247-817-11 RES, CARBON 270	1-247-688-11 RES, CARBON 10
R21	1-247-831-11 RES, CARBON 1K	1-249-401-11 RES, CARBON 47
Q7	2SB854	8-729-300-24 2SA1170
Q9	2SD1130	8-729-300-18 2SC2774
R42	1-247-831-11 RES, CARBON 1K	1-249-401-11 RES, CARBON 47
R43	1-247-817-11 RES, CARBON 270	1-247-688-11 RES, CARBON 10
R44	1-247-817-11 RES, CARBON 270	1-247-688-11 RES, CARBON 10
R45	1-247-831-11 RES, CARBON 1K	1-249-401-11 RES, CARBON 47

- 1.) confirm that transistors are good and reflow solder if necessary
- 2.) add 56pF caps in parallel with R29 and R53. If improved but not fixed, experiment.
- 3.) replace c1, c2, c3, c4 around 7815 / 7815
- 3.) Replace c11, c12, c13, c14, c15, c16, c17, c18
- 4.) note caps around Q3, Q5, Q7, Q9. These are supposed to reduce gain at high frequencies, but are not very effective
