MCI JH-110 Capstan Motor Disassembly
Copyright Dan Brown W1DAN

The two key items of a tape recorder are the condition of the heads and the stability of the tape path. Without a faithful transfer of the sound to and from the tape at a stable and accurate speed, the results can be unacceptable. The MCI JH-110 capstan motor (MCI PN ASA2500-0129-03 for high speed and ASA2500-0129-04 for low speed) was an excellent solution for its day, but has not fared well in aging compared to many simpler AC synchronous motors on decks such as the Ampex 350 and 440. As the MCI capstan motor is no longer available, I feel it is the Achilles-heel of these tape machines.

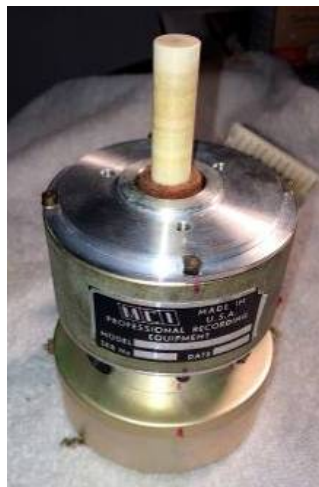
An MCI JH110 capstan motor

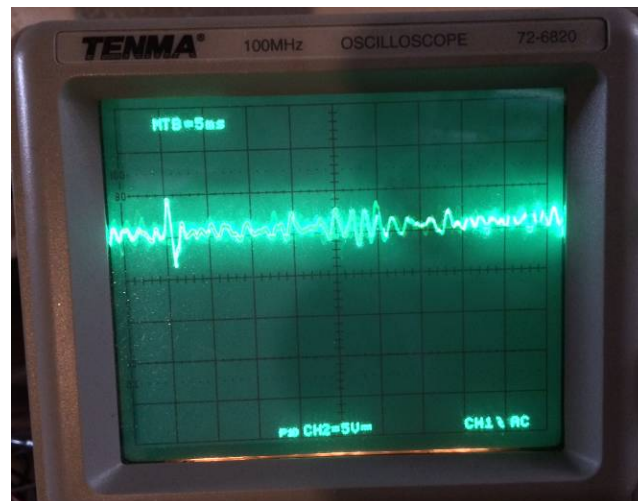
The voltages fed to the motor for each speed were measured on a sample deck to be 3VDC for 7.5IPS, 4.82VDC for 15IPS and 8.25VDC for 30IPS. The current drawn is under one amp for normal use and about $\frac{1}{2}$ amp while being fed from a bench supply at 13VDC under no load. In an MCI deck, the DC drive to the motor has correction signals added by the feedback system as seen below.

Peak "correction" modulation on the 5V DC drive voltage at the motor appears as waves and a 10V spike once per revolution.

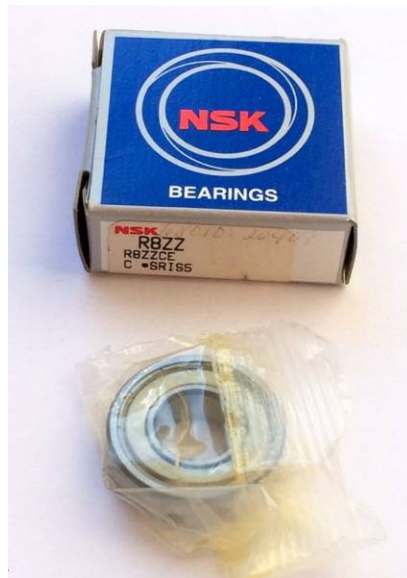
The original bearings used in the MCI capstan motor are model R8-Z (1/2" x 1-1/8" x 5/16" shielded, one side, deep groove bearings) made by GMN in Germany (<http://www.gmn.de/en/ball-bearings/service/downloads-catalogues.html>). A possible replacement is made by NSK of Japan. Bearings can often be sourced locally, or via US mail order. Amazon and eBay even have them. They cost somewhere around \$18.

An NSK bearing

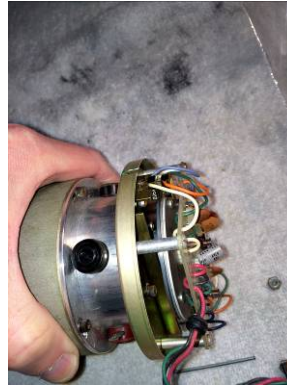
2. Unplug the motor and tach connectors from the transport motherboard.
3. Remove the top deck escutcheon. This requires that you remove all of the tape guide rollers, pinch roller and the head stack. Then unscrew the small black Allen screws to free the painted cover plate.
4. You will then see three flat-head screws near the capstan shaft. Mark the screw positions with a pencil. Carefully remove these screws while holding the motor from underneath. Carefully remove the motor to not damage the shaft. Slip off the mu-metal magnetic shield.
5. On a well-lit table or bench, place the motor on its side with a towel under it.
6. Remove the tachometer cover end bell.

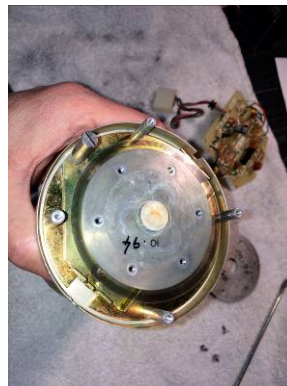
7. Unscrew the tach PC board.
8. Note how the photo-sensors sit within the encoder disk. Unscrew the two photo sensors and slip off the PC board with the sensors.
9. Remove the six small flat head screws and the pewter cover of the optical disk.

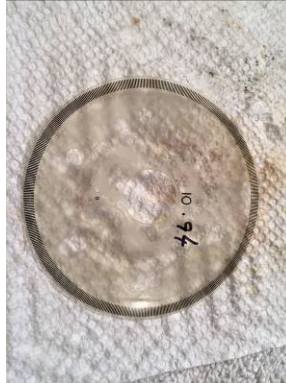
10. Carefully remove the optical disk and place in a safe place.

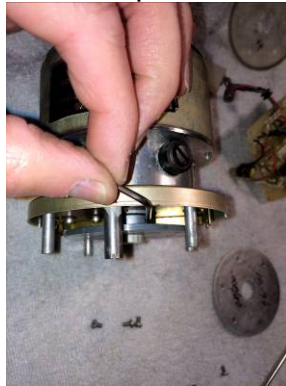
12. Measure the distance (or mark the motor shaft with the location) of the lower pewter disk plate.

13. Loosen the Allen screw that clamps the disk plate to the motor shaft.

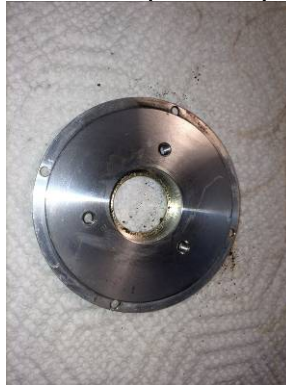
21. Using a soft hammer or end of a screwdriver, tap the top of the capstan shaft. The shaft should move down over time. You will eventually be able

to very carefully remove the top cover plate from the bearing.

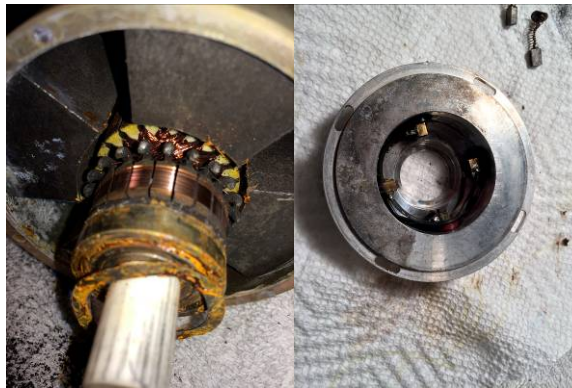
22. Heat and remove the bottom cover plate. Notice the pressure spring washer in the well of the bottom cover.

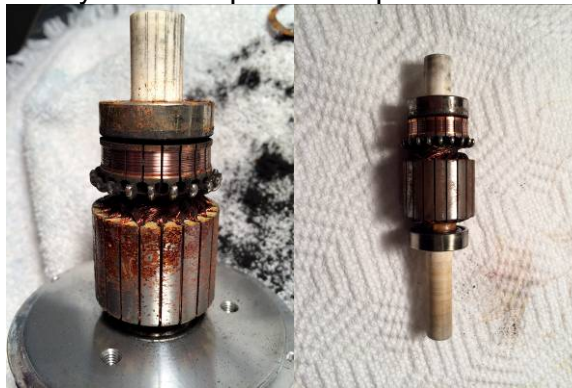
23. Carefully remove the armature from the magnet assembly.

24. Carefully clean all parts. Keep the shaft clean.

25. Heat and remove the bearings. You may need a bearing puller to do this. Install the replacement bearings.
